# Slip resistance testing of GRP flooring surfaces for Anglia Composites Ltd

**Report Number:**  
**ERG/18/05**

This report presents the results of laboratory based slip resistance testing of four GRP flooring samples supplied by Anglia Composites Limited, at the request of Mr. Keith Bareham. Testing was carried out by Mr. Mark Liddle on the 23<sup>rd</sup> January 2018.

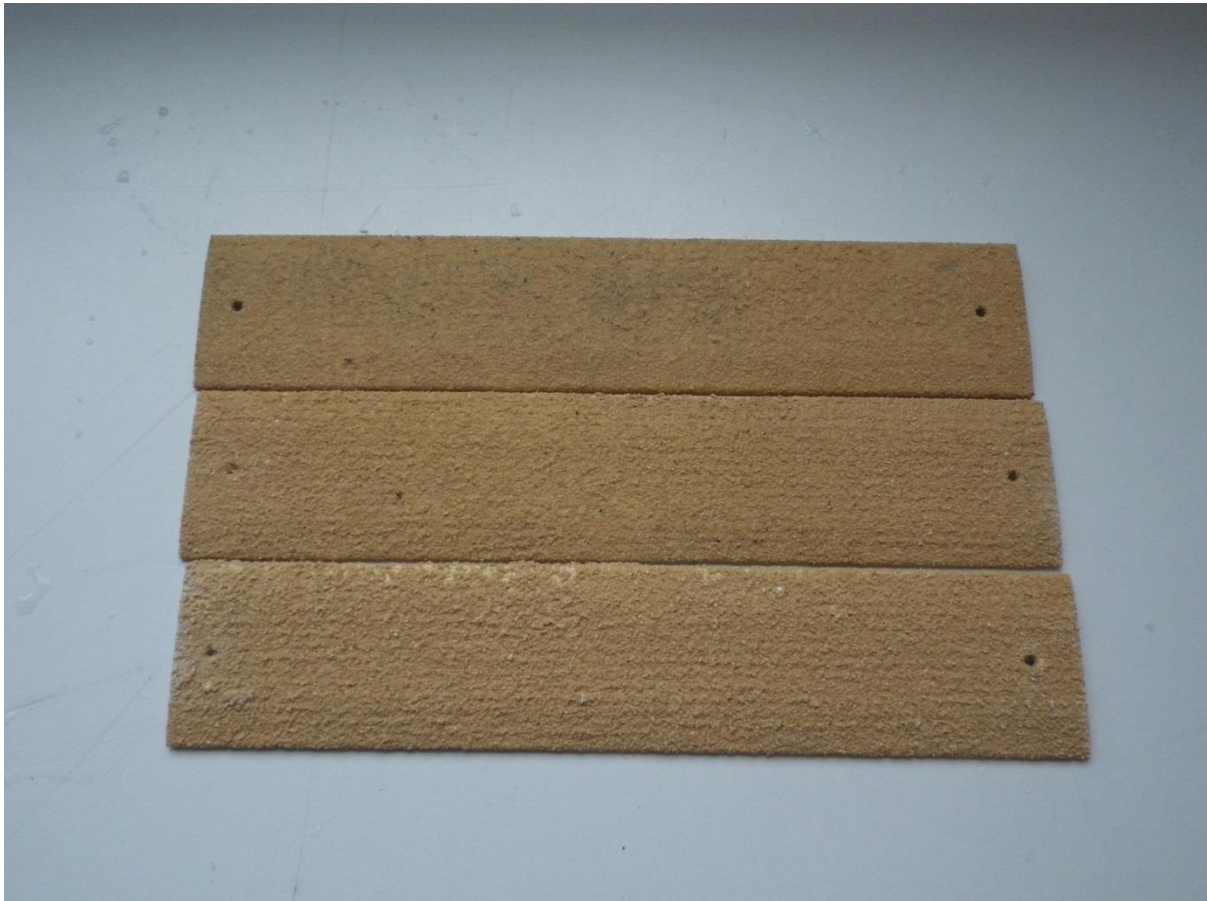
HSL Sample I.D. FAL/18/4

<b>Sample details</b>		GRP insert strips with aggregate on walking surface		
<b>Slider</b>	<b>Condition</b>	<b>Test Direction</b>	<b>PTV</b>	<b>Slip Potential on level</b>
96	Clean, dry	1	78	Low
		2	77	Low
		3	77	Low
	Water contaminated	1	75	Low
		2	74	Low
		3	69	Low

Note: Multiple strips were positioned side by side (as shown above) to create a large enough test area to accommodate the pendulum footprint.

The GRP insert strips were approximately 52 mm wide and so multiple strips were positioned side by side to create a test area large enough to accommodate the pendulum footprint.

It should be noted that low slip potential presented by the GRP insert strips (FAL/18/4) is based on results generated when the strips are placed side by side with minimal gaps, to maximise contact with the pendulum slider. This however may not reflect how the strips will be used. If there is spacing between the GRP strips large enough for a pedestrians foot to make contact with the substrate to which they are attached, the slip potential of the walking surface will be influenced by the slip resistance of the substrate.
